## Electronic multi-urinal flush valve with infrared beam

Reference: **SLP05K**

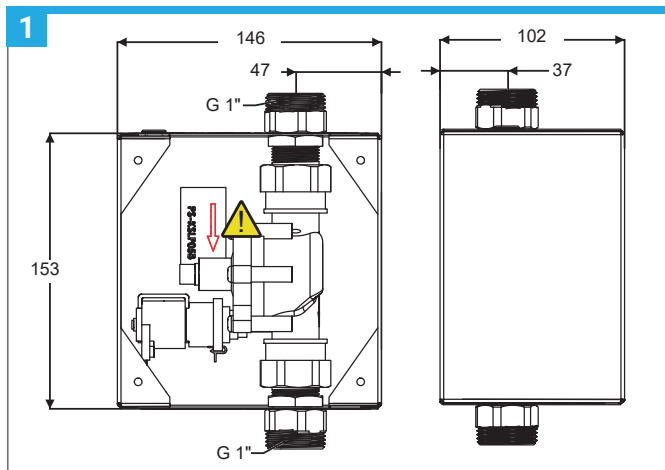
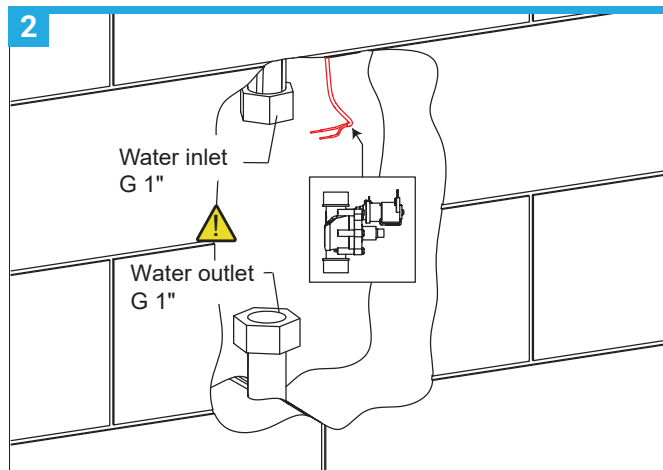
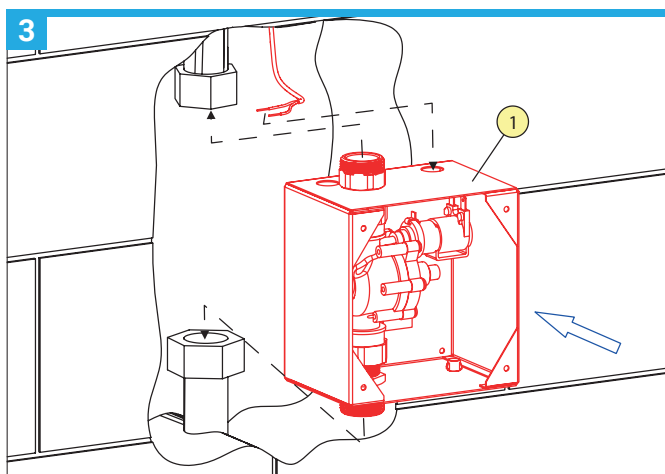
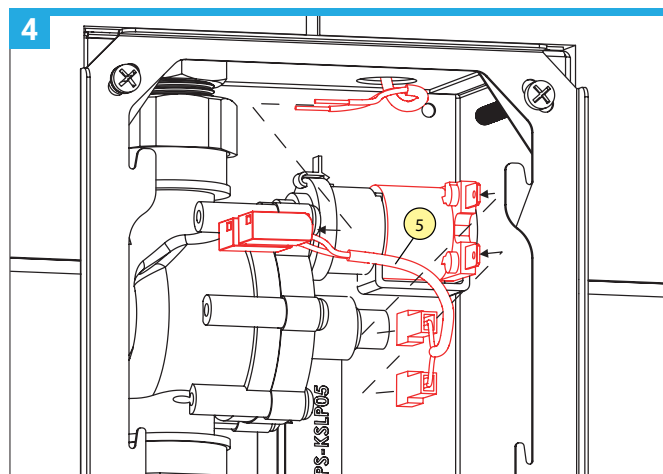
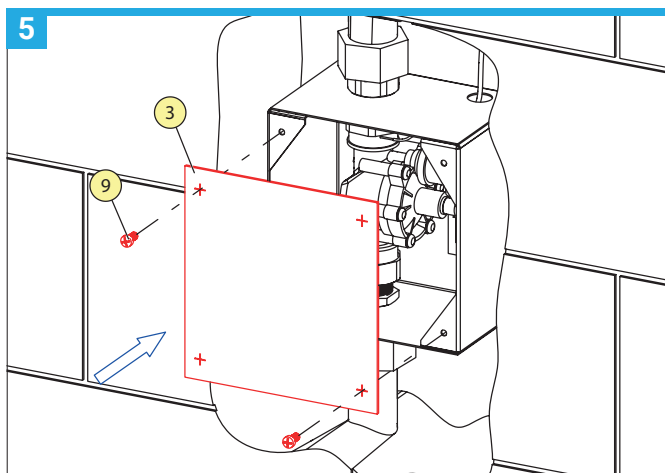
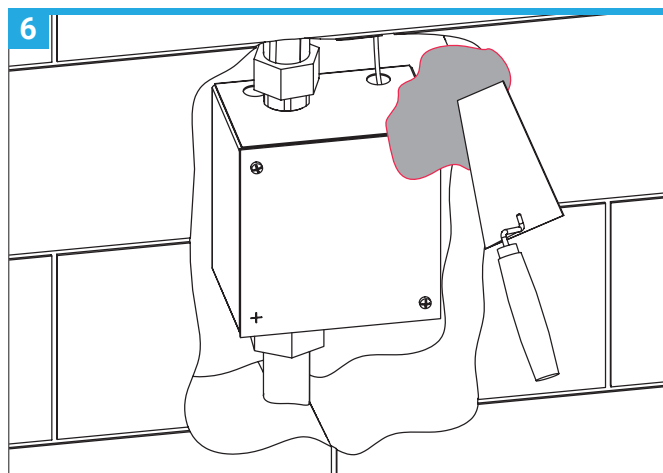
## INSTALLATION / SELENOID VALVE HOUSING - 1

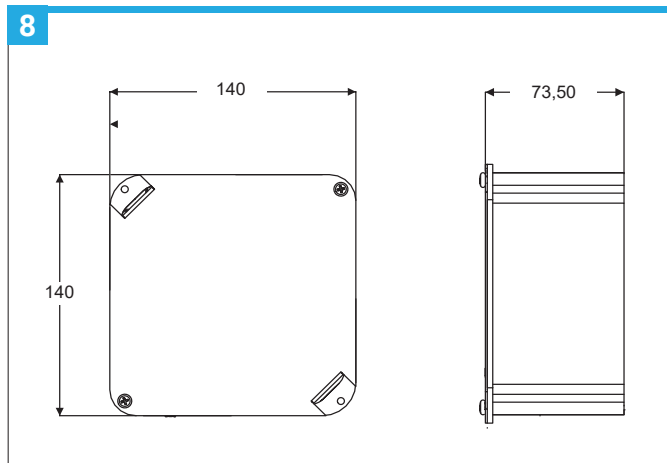
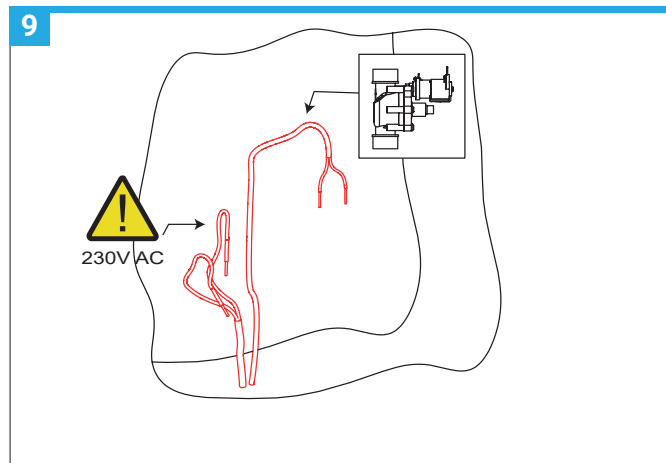
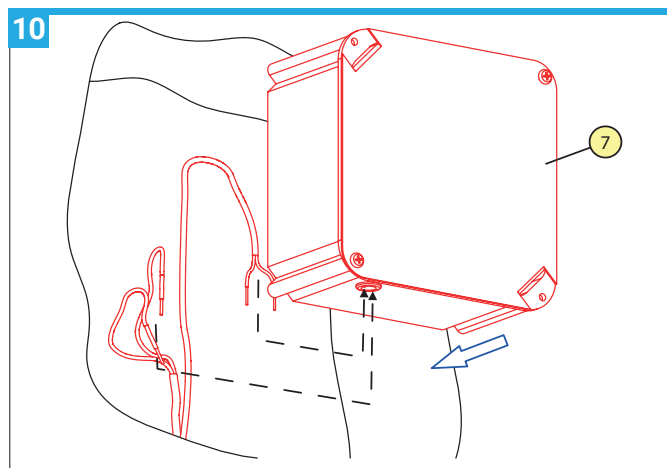
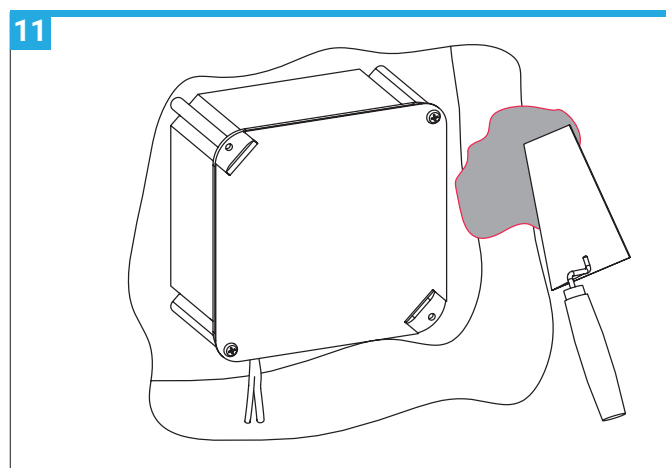
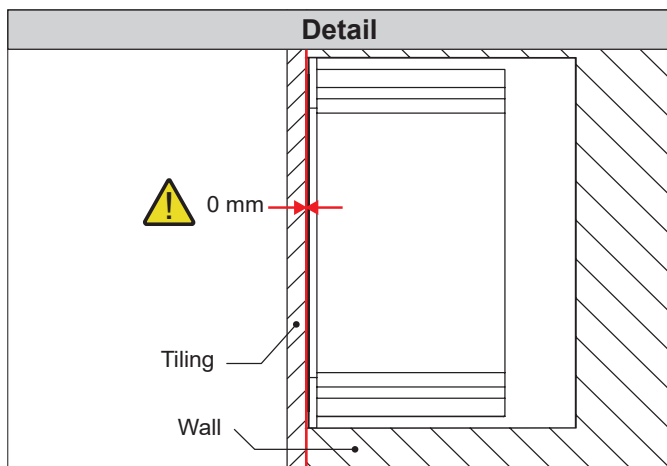
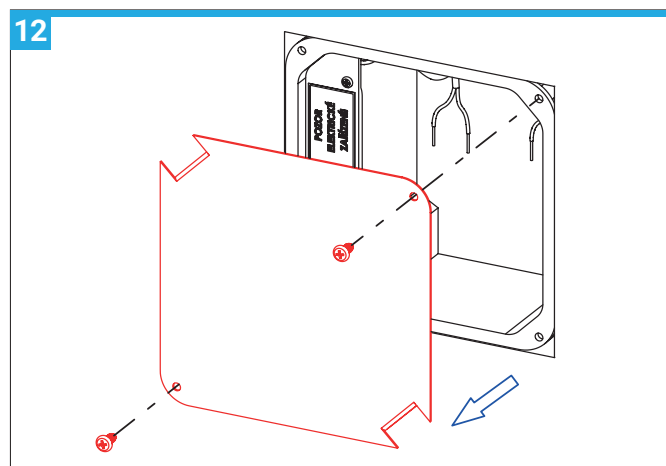
## INSTALLATION / RECESS BOX - 7

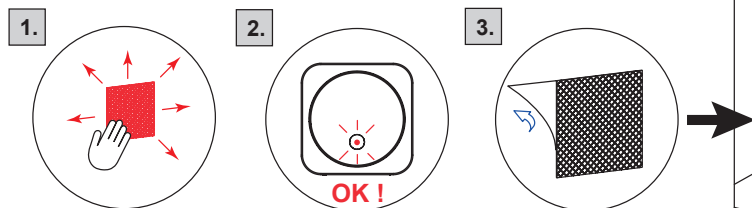
27

Move reflexive foil along the opposite wall as long as diode lights up.
